The Volt Vette Project

Chapter 34

The Ring is the Thing

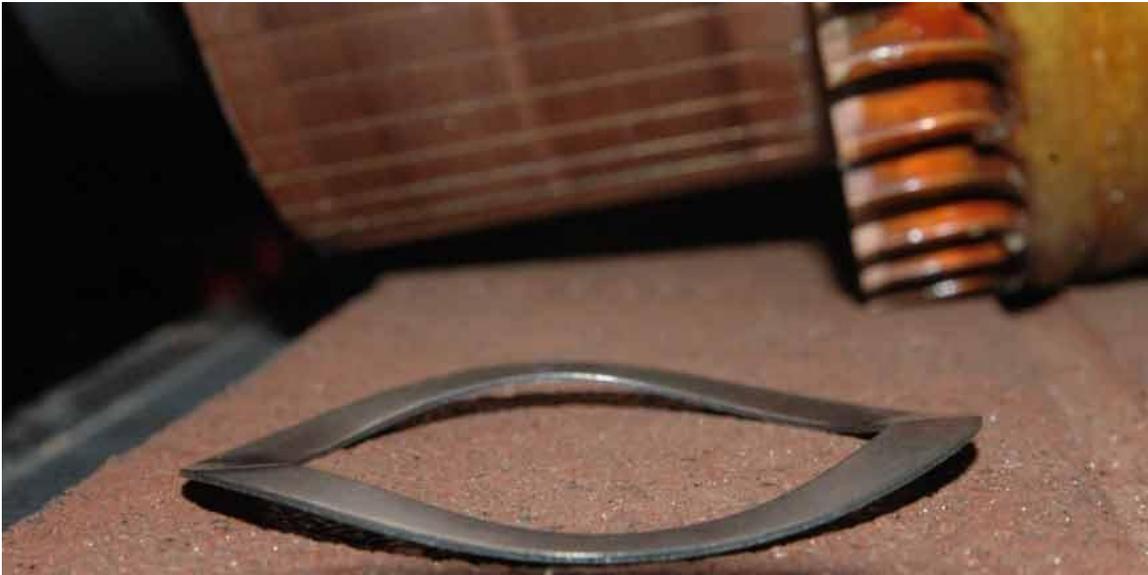
What is this thing?

It fell out of the TransWarp 11 electric motor when I first tore it apart, over a year. If I had been smart, I would have quickly called the people who designed the motor. But long-time readers know I'm not very smart.

Many months went by before I found out that this unusual warped washer is designed to keep the armature from moving backward and forward inside the motor housing. Sort of a minimalist shock absorber.

The designers want the washer back inside the motor, but at this late date, that will not be easy.

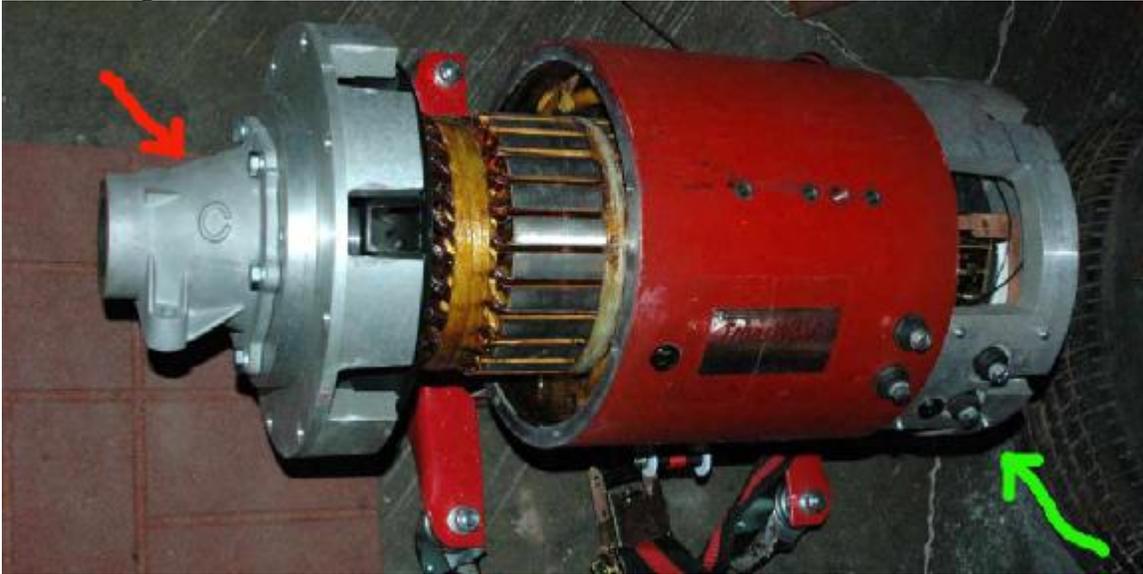
In this photo, the red arrow points to the bell end and the green arrow points to the end that should hold the washer!

With the bell unbolted two facts hit me. One, the washer does not fit.

Two, the too short driveshaft, I recently replaced, seems to have destroyed the internal bronze bushing hidden inside the bell.

But first, the bushing needs to be replaced. Another job I can't do! One week and \$600 later, I get down to some warped washer work.

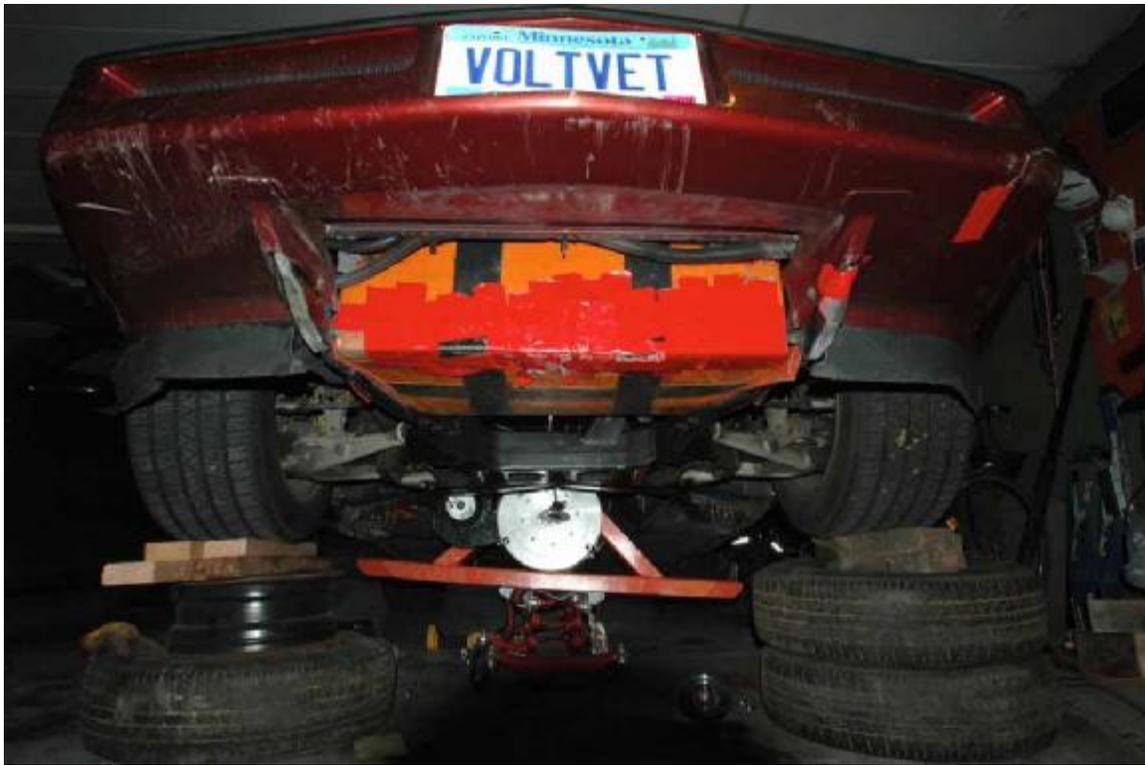
I dust off my tranny jack and use it to lower the motor.

With about a thousand miles on it, the motor was much more difficult to get apart than when it was brand new.

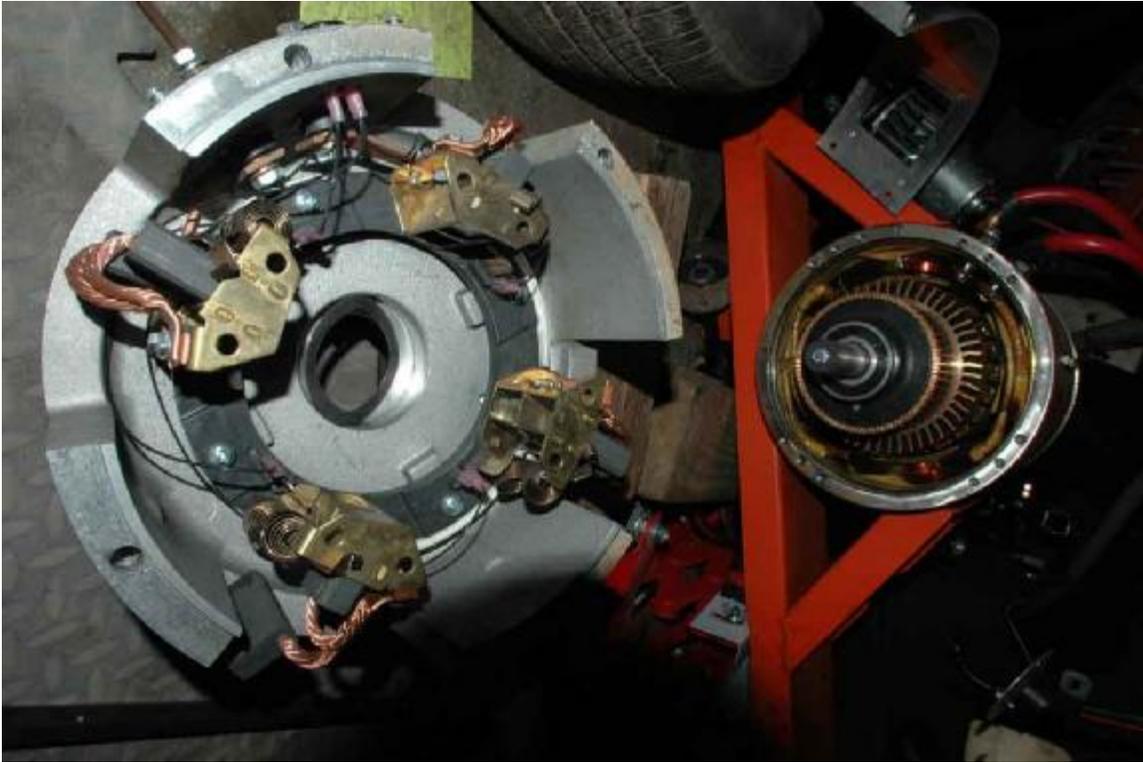
The washer fits easily into the tail end of the motor. What a relief!

After another 12 hours of very hard work, the Volt Vette was on the road and being driven every day.
